# Sample Machine Risk Assessment Report Output

Machine & Assessment Details									
Machine Description	Flow Wrapper					Photo Ref	LWH	Inspection Date	10/07/2019
Department	Bar Line	Area	Packing					Asset Code	
Author	Risk Assessor			Completed With (Personnel Name)		John Jones			
Physical Limits of the Machine Risk Assessment	As per the physical limits of the flow wrapper			Scope & Limits of the Machine Risk Assessment		The equipment itself and significant hazards directly related to it but not the environment or surrounding activities. Hazards being assessed do not include manual handling related hazards, insignificant hazards or slip and trip hazards. Only operational life cycle is evaluated.			
Operating Lifecycle Information									
General Equipment & Process Desc	Standard Campbell flow wrapper used to wrap, seal and cut plastic film around bars. A series of in-feed belt conveyors transport bars from the accumulator, rotate them 90°, then accumulate and queue them for the flow wrapper stage.

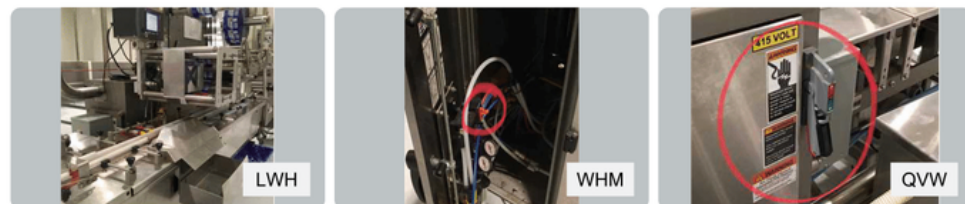
Start Up	Film is loaded onto an overhead mandrel and threaded around rollers into the sealing section. Product is loaded onto the feed conveyor and the machine is turned on			Cleaning		Manually wiped down			
Normal Operation	Runs continuously providing product is available. If product flow stops, the wrapper process stops.			Trouble Shooting		No specific problems noted however access into the sealing section of the machine to clear mis-fed product and to clean the sealing/cutting bars is likely to be required			
End of Run	No special activities - product is run out and machine is turned off			Maintenance		Periodic checking of drive chains and sprocket condition as well as lubrication is required			
General Comments	Type C standard EN 415-3 and AS/NZS 4024 has been used as the main reference document for this MRA								
Existing Controls									
Fixed Guards	The flow wrapper is fitted with a combination of fixed and interlocked guards (not compliant).			Interlocks/Safety Functions		An interlock is fitted to the guard over the metering unit, the side wrap unit, and the guard over the rotary end sealer.

Warning Signs/Indication	Stickers positioned on fixed guards indicate that guarding must be in place before operating the machine. A sticker positioned at the entry point into wrapping indicates to keep hands clear of pushers.			E-Stops		One chest-height (~1.4m) Emergency Stop pull wire running the length of the in-feed/rotation/metering stage, up to the flow wrapper unwinding section. One Emergency Stop button at the operator control panel within reach of the rotary end sealer.			
Energy Source	Description	Photo	Significant Hazard?	Isolation Device	Designation Coding	Lockable	Required Isolation Method (Current Isolation Devices)		Suitably Identifiable
Electricity	Powers conveyors, fin sealing wheels, rotary end sealer, and heaters.	QVW	Yes	Electrical isolation switch		Yes	Padlock through lockable device		Intuitively easy to identify, but not labelled
	Remedial Work / Comments	Voltage and hazard labels, but nothing to indicate this is the main isolator. Meaningful "main isolator" labelling is required.

Pneumatic	Powers pneumatic parts e.g. splicers, brakes, sealing pressure, printer head	WHM	Yes	Exhausting Isolation Valve		Yes	Padlock through lockable device		Not easy to identify
	Remedial Work / Comments	Lockable exhausting isolation valve is fitted to the inside of a cabinet door. No labelling or indication was given for the location of the isolator. Meaningful labelling is required for pneumatic isolator, and additional air line/s appear to be tee'd off before the isolator - these require further investigation.							
Machine Overview Photos

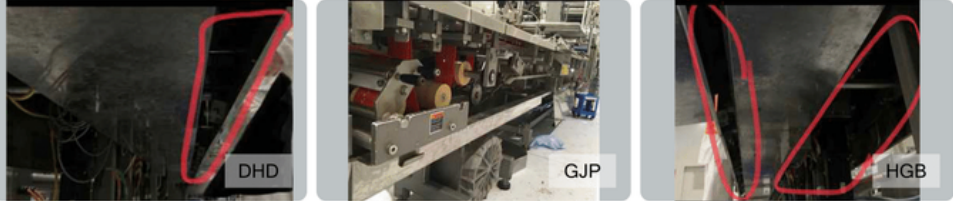
Hazards, Risks and Controls Assessment						
Hazard Assessment	Description			Consequence		Source
	Fingertip amputation due to crushing/shearing as feed chain lugs pass fixed objects (e.g. guards/apertures), caused by unexpected startup during maintenance.			Amputation - Fingertip (no bone)		Tools/Machinery
Raw Risk Assessment	Raw Risk Estimation (Risk Matrix)			Performance Level Assessment (NZS4024.1503)		
	Consequence Rating	Likelihood of Occurrence	Risk Score	Frequency of Exposure (more freq. than)	Possibility of Avoidance	PL Required
	Moderate (3)	Possible (3)	Moderate (9)	Daily	Possible	c
Hazard and Control Photos

Controls	Description	Status	Photo Ref	Control Type	Relevant Standard	Budget Cost
	Emergency Stop pull wire installed along the length of the in-feed section.	Existing		Engineering	EN 415-3	
	Existing guarding design reduces the risk of reaching into the hazard zone (not compliant as reach is generally not prevented from below or through aperture)	Existing	HGB, GJP, DHD	Engineering	EN 415-3

Local electrical isolation	Existing		Engineering		
	Prevent lugs shearing fingers if they are inserted through the head aperture - install an internal tunnel guard. A cheek plate on each side of the lug path within 5mm in accordance with AS/NZS 4024.1801 and AS/NZS 4024.3610 is likely suitable.	Required		Engineering - Mechanical	AS/NZS 4024.1801	500
	Prevent contact with transmission/belt/chain hazards by installing additional guarding in accordance with AS/NZS 4024.1801. Up to 30x30mm square mesh or 20mm slots may be suitable.	Cross Reference		Engineering - Mechanical	EN 415-3	
Current & Future RA	Current Risk Estimation (Risk Matrix)			Future Risk Estimation (Risk Matrix)		
	Consequence Rating	Likelihood of Occurrence	Risk Score	Consequence Rating	Likelihood of Occurrence	Risk Score
	Moderate (3)	Unlikely (2)	Moderate (6)	Moderate (3)	Rare (1)	Low (3)
